Addressing land based sources of pollution in Guánica, Puerto Rico

Abstract. The Guánica Bay/Rio Loco (GB/RL) watershed is located in the southwestern corner of Puerto Rico, approximately 20 miles west of the city of Ponce. Due to human alteration, the watershed area was increased by 50% to approximately 151 square miles and discharges to Guánica Bay near the town of Guánica. The Guánica Bay/Rio Loco watershed includes the urbanized areas of Yauco, a portion of the Lajas Valley agricultural region, and the upper watershed where coffee farming and subsistence agriculture is practiced on steep often highly erodible slopes. The GB/RL is one of the major riverine discharge points in the southwest coast. Historically, the area was associated with some of the most extensive and healthy reef complexes in Puerto Rico. Coral reefs have experienced an unprecedented decline over the past 30-40 years in the Caribbean by some estimates have lost greater than 50% of live coral and over 90% of sensitive and federally listed *Acropora palmata* (elkhorn) and *Acropora cervicornis* (staghorn) species. Meanwhile studies by scientists in Puerto Rico have suggested that important nutrient and sediment

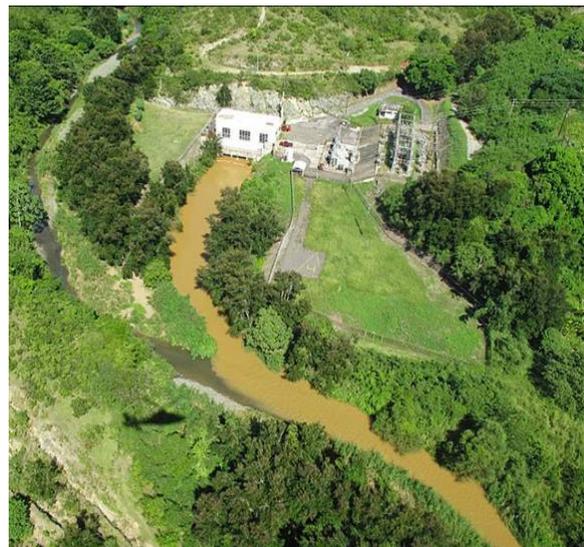
Figure 2: The pumphouse into Lago Loco reservoir from Lago Lucchetti demonstrating interbasin transfer of sediment.

A review of orthophotography with DNER biologists at Guánica Forest Reserve clearly showed that sediment was passing through the Rio Loco Reservoir through the watershed and into Guánica Bay. Even closer inspection revealed at least some of the sediment laden water was being discharged from the pump/flow house draining from Lucchetti Reservoir into Loco (Fig. 2). The reddish clay colored water was clearly visible in the Rio Loco below the dam and extending down to the Guánica Bay and out to the near shore coral reefs.

Lucchetti is also discharging fine sediment from its intake pipe to Loco Reservoir because the pipe invert is estimated to be at the same elevation or below the estimated current reservoir bottom due to sedimentation as was predicted by Ortiz-Zayas & Terrasa-Soler (2001). Personal communication with USGS and GIS orthophotography zoomed in on the pump house into Loco Reservoir confirms this occurrence (Fig. 2). The extent of storage losses in the reservoirs in the watershed is documented in Soler-Lopez (2001). Extensive sedimentation is present in four of the five reservoirs in the watershed.

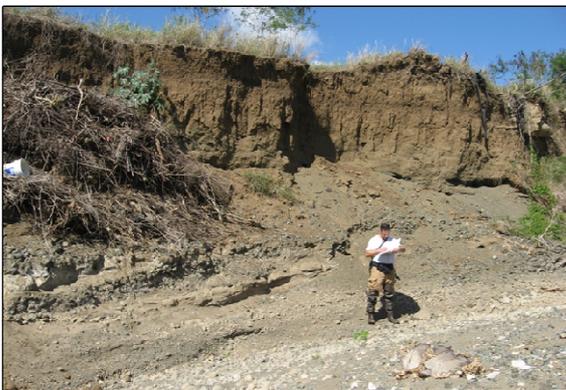
Figure 3: Unstable legacy sediments deposited in the Rio Loco/Guánica Valley.

Channel erosion on the main stem of Rio Loco was another major issue in the watershed as documented using a qualitative Rapid Geomorphic Assessment (RGA) (MacRae and DeAndrea, 1999). Severe erosion was associated with areas that lacked mature riparian trees, the occurrence of non-native species that seemed to exacerbate erosion and areas with historic irrigation infrastructure which created downstream scour (Fig. 3). These low head dams, concrete footers, and other structures cause debris to become lodged in the channel, destabilize banks, and increase channel erosion, bed scour, and sediment transport. Clark and

Wilcock (2000) discussed the deposition of valley sediments during the period of deforestation and intense agriculture and the continued importance of these historically deposited valley sediments as significant contributors to the current and future sediment regime and Warne et. al. (2005) noted the resulting continued impact on nearshore coral reef ecosystems.
